STRUCTURAL EVALUATION REPORT

**INSPECTION & EVALUATION
OF THE
LOWER MAKEFIELD TOWNSHIP COMMUNITY POOL
LOCATED IN
LOWER MAKEFIELD, PENNSYLVANIA**

**THE TOWNSHIP OF LOWER MAKEFIELD
110 EDGEWOOD ROAD
YARDLEY, PA 19067**

NOVEMBER 2018

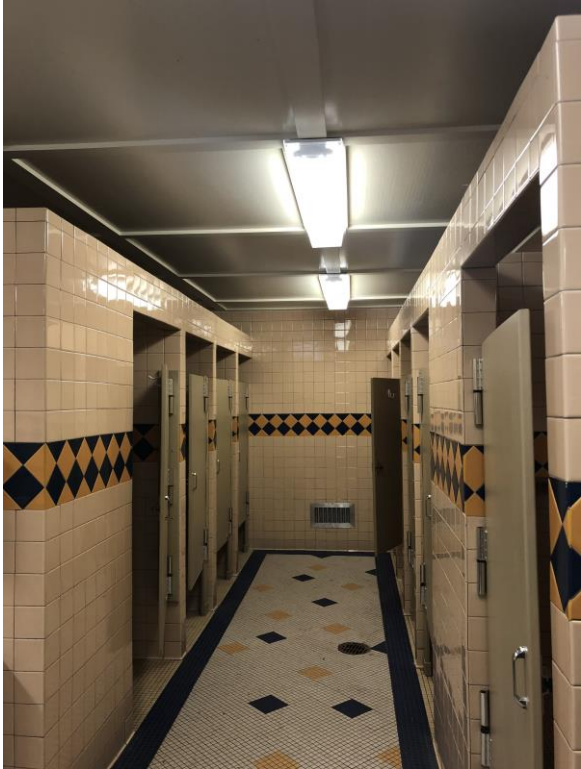
These bathrooms are in fair condition. In both the male and female areas, showers and water closets are provided. Existing shower and water closet partition walls are non load-bearing walls with tile cladding. These may be removed and replaced with shower stalls. New shower stalls should incorporate an elevated changing area. Existing shower fixtures should also be replaced with new. Existing bathroom fixtures, including light fixtures, mirrors, sinks, faucets, soap dispensers are stainless steel, showing surface rust and should be replaced. All walls and floors are tile-clad. Existing wall and floor tile may be removed and replaced. The existing ceiling is in good condition and should be cleaned and re-painted. A single changing bench is provided in the locker room area of both the men's and women's bathrooms. This bench may be cleaned and painted to match new finishes. The lockers in both rooms should be cleaned and painted.

Figure 2 - Main Office Bathrooms - Partition Walls

1. Remove and replace existing fixtures, including light fixtures, mirrors, faucets, soap dispensers, and appurtenances.
2. Demolish existing tiled shower partition walls.
3. Remove and replace wall and floor tile.
4. Install new shower stalls with elevated changing area.
5. Remove and replace existing shower fixtures.
6. Install air conditioning system.
7. Clean and paint existing ceilings, benches, and lockers.

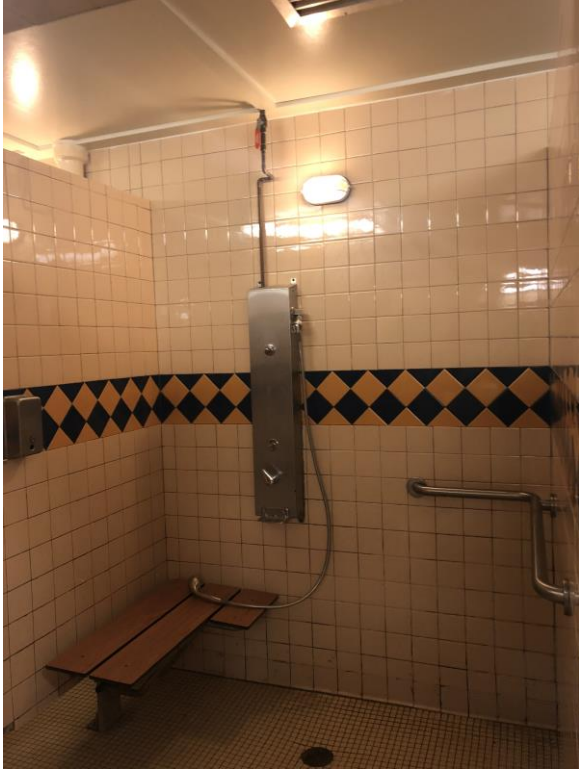
Figure 3 - Main Office Bathrooms - ADA Shower Stall

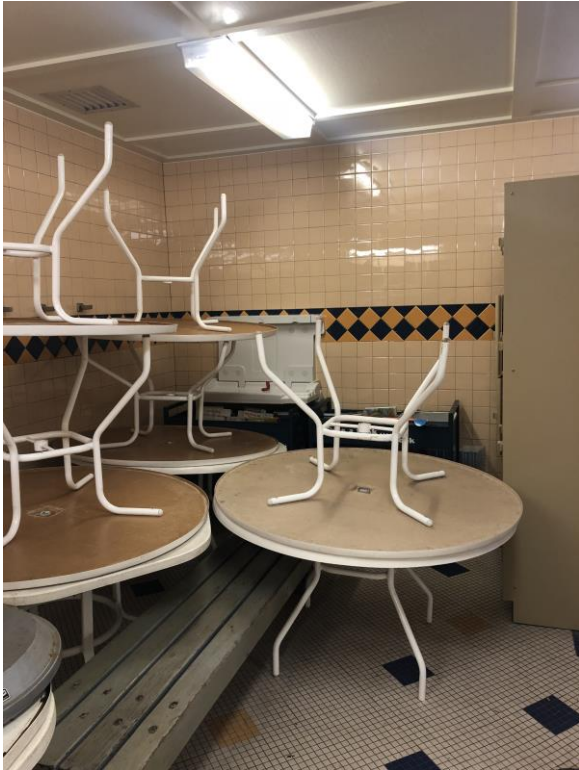
Figure 4 - Main Office Bathrooms - Bench and Lockers

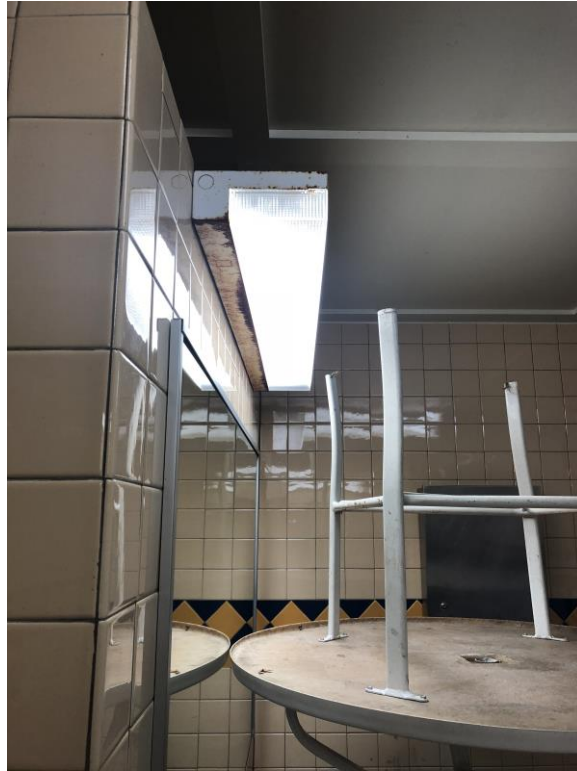
Figure 5 - Main Office Bathrooms - Rusted Fixtures

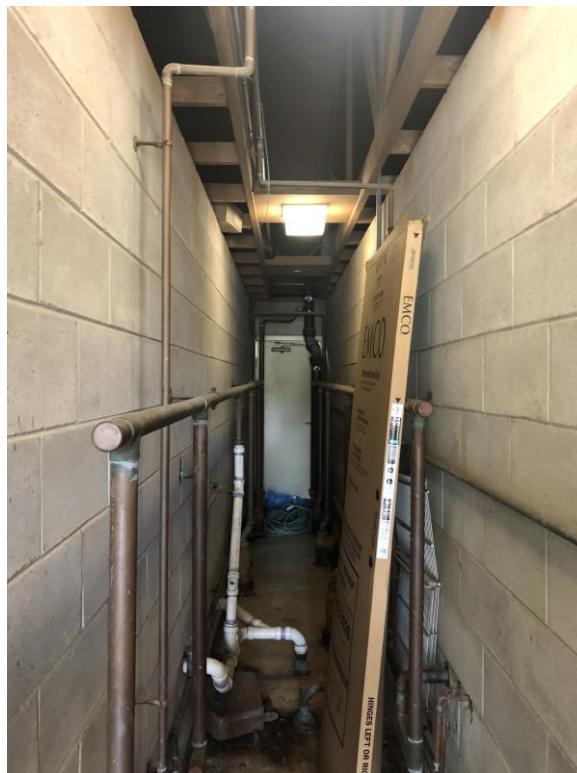
An air conditioning system was not present at the time of inspection in either the men's or women's bathroom. Exhaust fans are provided for ventilation in both areas. An air conditioning system may be added, with new units located adjacent to the existing exhaust fans in the attic space available in the open A-frame truss webs.

Figure 6 -Main Office Bathrooms - Interstitial Space with Attic Access

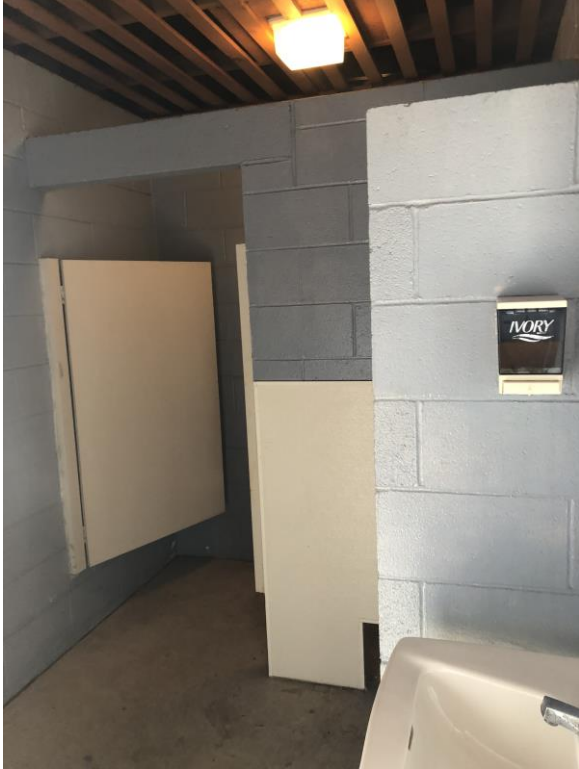
The south bathrooms are located near the pool entrance at the south of the site. These bathrooms, consisting of two stalls and a sink, are in fair condition. No closed ceiling is provided in the bathroom. A moisture-rated gypsum board ceiling should be fastened to the existing wood strip ceiling to provide a closed space. Existing fixtures, including light fixtures, mirrors, faucets, and soap dispensers are in need of replacement. Existing sinks, stalls, and water closets are also in need of replacement. Existing painted concrete masonry unit (CMU) walls should be cleaned and repainted. The existing steel door is operable with rusted hardware. Door hardware should be replaced, and the door cleaned and painted to prevent rusting.

Figure 7 - South Bathrooms - Interior of Men's Bathroom

1. Remove and replace existing fixtures, including light fixtures, mirrors, faucets, soap dispensers, door hardware, and appurtenances.
2. Remove and replace existing sinks and water closets.
3. Remove and replace existing stalls.
4. Install moisture-resistant gypsum board ceiling.
5. Remove and replace existing wall vents.
6. Install air conditioning system.
7. Clean and paint existing walls, ceilings, and doors.

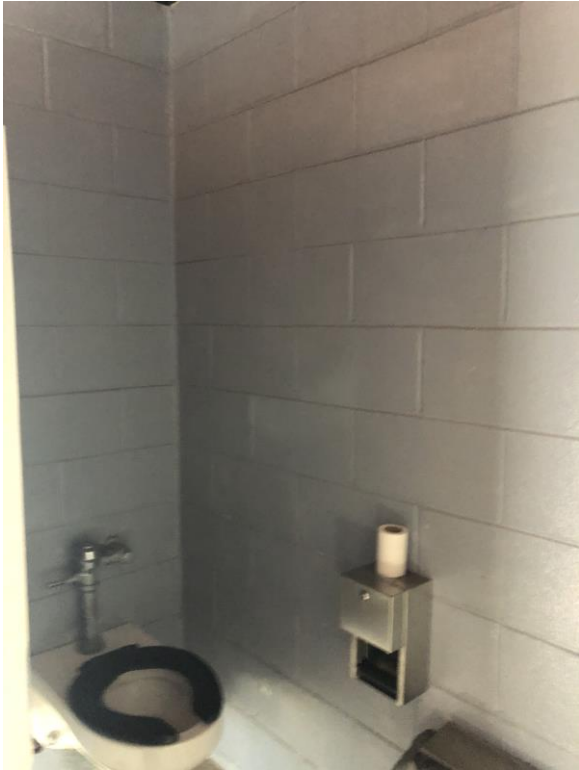
Figure 8 - South Bathrooms - Existing Water Closet and Fixtures

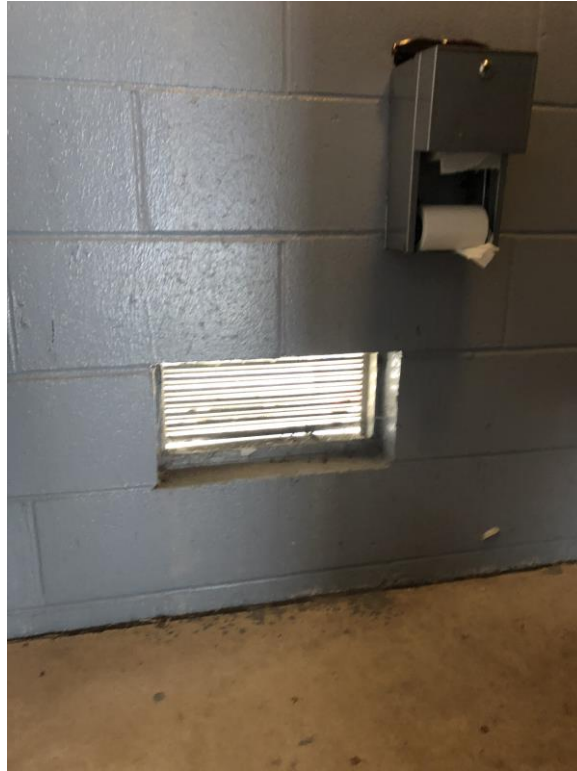
Ventilation is provided by way of a louvered wall vent provided in the single-wythe CMU wall. The wall vent should be removed and replaced with an operable vent. Further ventilation may be provided by installing an air

Figure 9 - South Bathrooms - Louvered Through-Wall Exhaust Vent

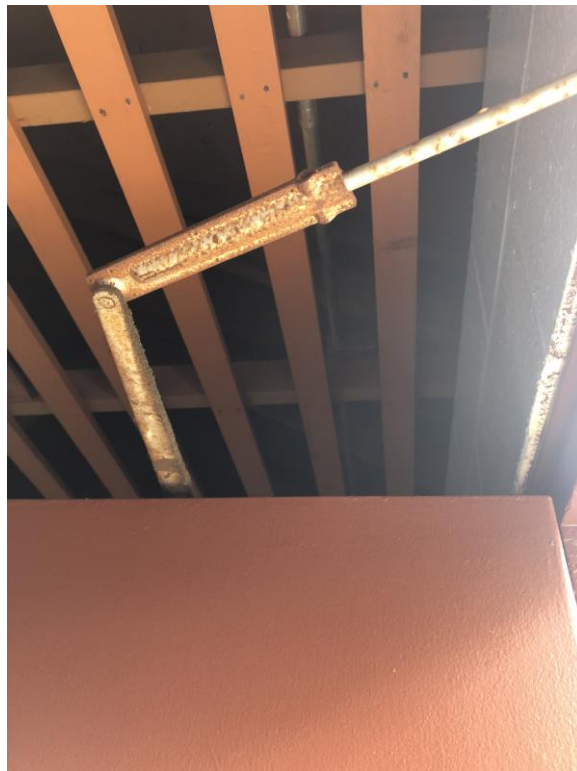
Figure 10 - South Bathrooms - Rusted Door Hardware

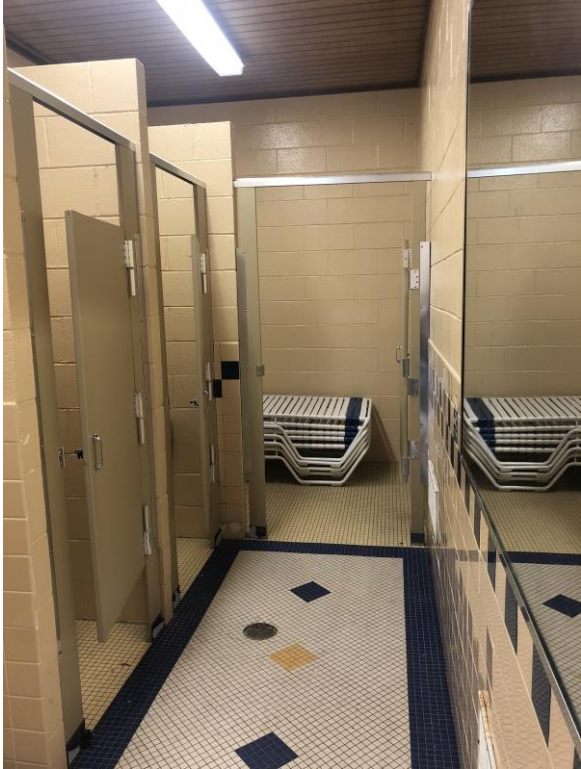
The north bathrooms are located in an outbuilding at the north end of the site. These bathrooms consisting of several stalls and a changing area are in fair condition. The existing ceiling should be cleaned and re-finished. Existing fixtures, including light fixtures, mirrors, faucets, and soap dispensers are showing surface rust and should be removed and replaced. Existing stalls should be removed and replaced. Tile is present on the floors, and to half-height on the walls. Existing wall and floor tile may be removed and replaced.

Figure 11 - North Bathrooms - Typical Interior Stalls with ADA Stall at End

1. Remove and replace existing fixtures, including light fixtures, mirrors, faucets, soap dispensers, and appurtenances.
2. Remove and replace existing stalls.
3. Remove and replace existing wall and floor tile.
4. Repair existing ventilation / air conditioning system.
5. Clean and re-finish existing ceilings.

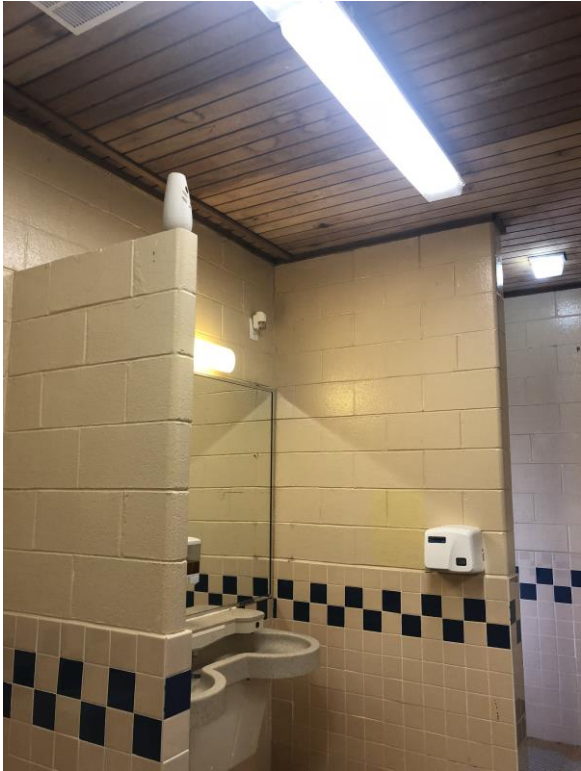
Figure 12 - North Bathrooms - Sink Area

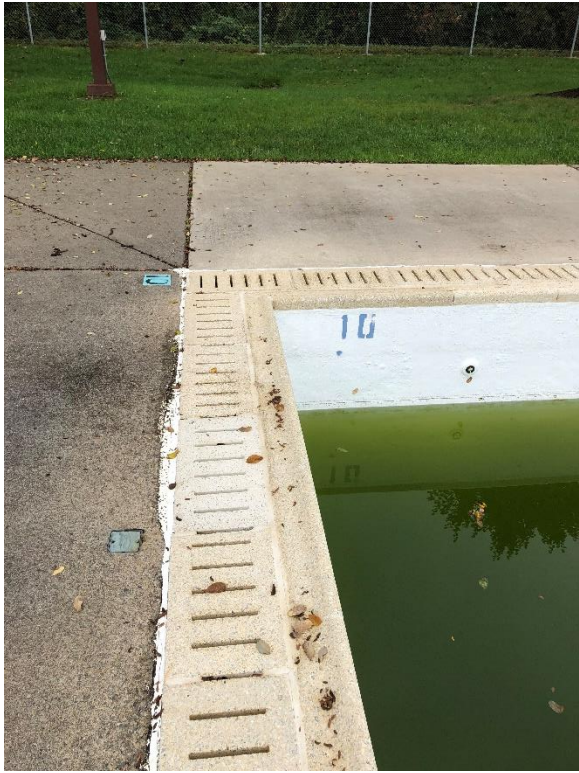
The perimeter concrete gutter could not be fully inspected since the concrete grating is mortared in place. In order to ensure that this area is properly sealed and not leaking all the concrete grating should be removed. This will allow proper concrete repairs to any existing cracking and spalling in the water return gutter. Once repairs are completed, the entire concrete gutter can be sealed with concrete surface sealer to prevent leakage.

Figure 14 – Concrete Perimeter Gutter System

3. Re-coat the existing pool walls in all areas of the completed repairs to seal the wall and to match the existing pool finish.
4. Repair the concrete perimeter gutter by removing the existing concrete grating to expose the gutter. Repair all concrete cracks and spalls as noted previously. Provide a concrete sealing product on all surfaces of the gutter. Re-install the concrete grating and pool edge pieces.

5. An alternate design would be to replace the concrete perimeter gutter with a stainless steel gutter system which will function as the skimmer and water return system. This could be similar to the existing system on the adjacent pool. This installation would provide a long term more maintenance free solution to a concrete gutter which will require yearly maintenance and repairs. The stainless steel gutter system would have a warranty of 15 or 20 years compared to the repairs of the concrete gutter system which may have a 3 to 5 year life before additional maintenance is required.

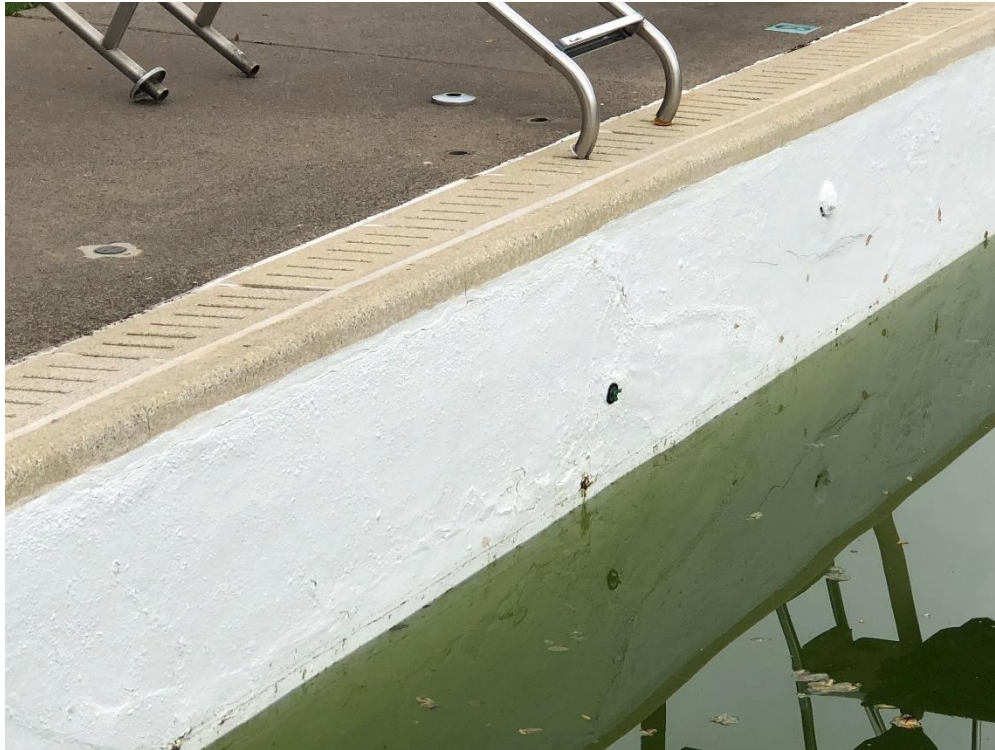
There were cracks and concrete spalls observed near the top two to three feet of the concrete perimeter walls. These have also appeared to have been previously repaired several times. Prior to any repairs, all loose concrete and any previous repair materials shall be removed down to the original concrete pool walls.

Figure 15 – Top 2 to 3 feet of Side Walls and Concrete Perimeter Gutter

2. Repair and concrete cracks and spalls in the top 2 to 3 feet of the existing pool walls. Concrete crack shall be cleaned of all loose materials and sawcut to provide a good surface for repairs. Concrete spalls also be prepared by removing all loose materials and using a sawcut around the perimeter in order to provide a proper surface for repairs. Use concrete repair products to waterproof and seal the existing joints and prevent water leakage.

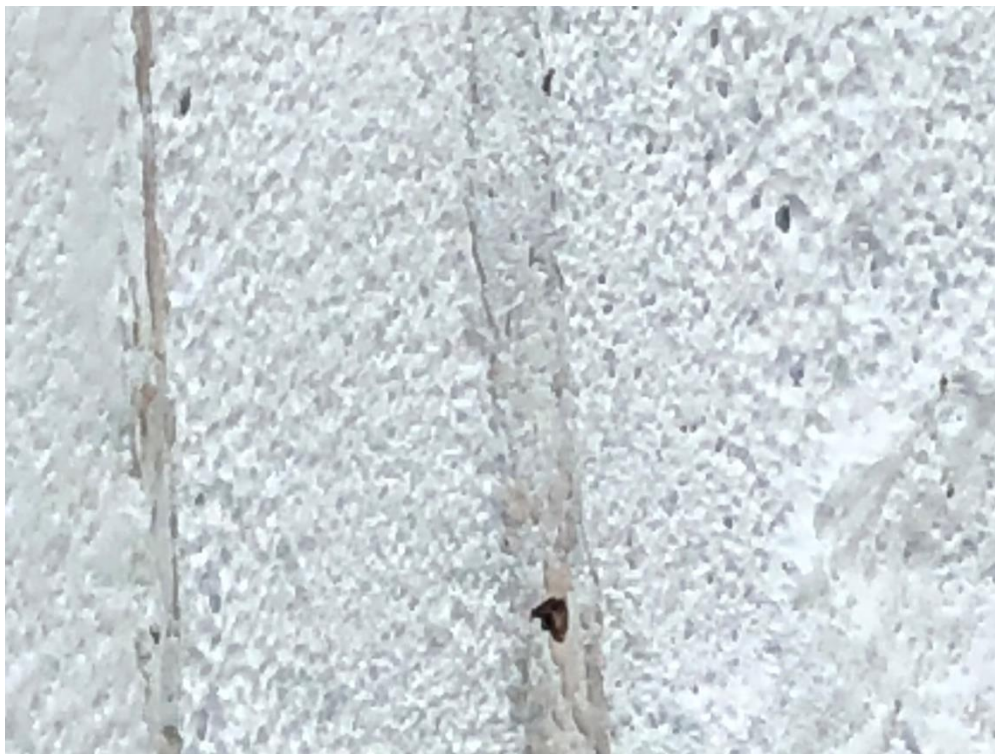
Figure 16 – Previous Crack Repairs and Surface Pitting

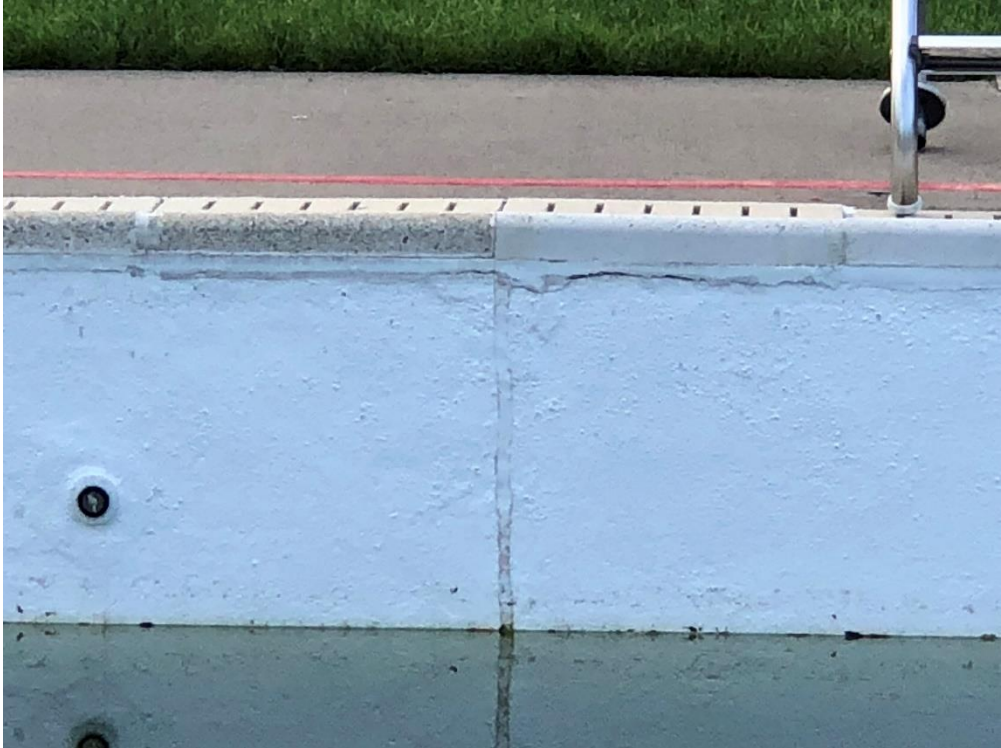
The existing vertical construction joint appears to have been repaired several times in the past. Therefore, the repair must include removing all loose materials and previous repairs down to the original pool wall structure. The joint can then be properly repaired and sealed to prevent water leakage.

Figure 17 – Vertical Construction Joint and Horizontal Crack below Gutter

1. Repair the vertical construction joints in the existing pool walls by first removing all loose concrete and any previous concrete repair materials down to the original wall construction. Use concrete repair products to waterproof and seal the existing joints and prevent water leakage.
