RE: Safety Assessment of Municipal Pool

**RECOMMENDATIONS  
POOL**

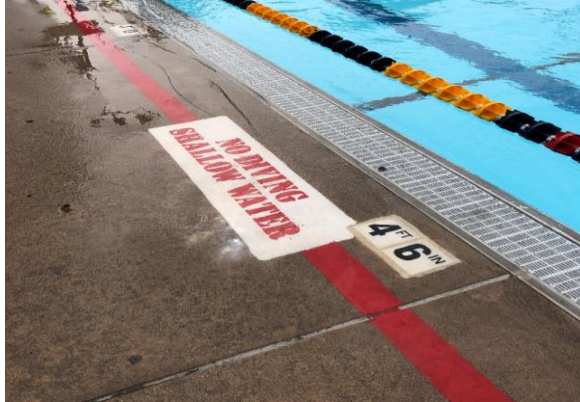
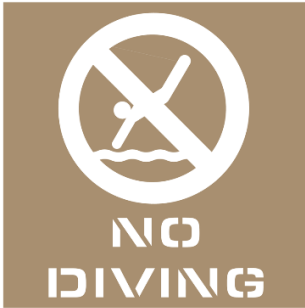
Rec. No.: 19-07-5	Priority: B	Pool – “No Diving” Pictograms
In conformance with the International Pool and Spa Code, it is recommended that Lower Makefield apply “No Diving” pictograms and depth markers as follows:		
<p><i>409.3 No diving symbol.</i>  <i>Where the pool depth is 5 feet or less, the “No Diving” symbol shall be displayed. The symbol shall be placed on the deck at intervals of not greater than 25 feet and directly adjacent to a depth marker. Additional signage shall be in accordance with NEMA Z535.</i></p>		
<p>Source:  <a href="https://codes.iccsafe.org/content/ISPSC2018/chapter-4-public-swimming-pools">https://codes.iccsafe.org/content/ISPSC2018/chapter-4-public-swimming-pools</a></p>

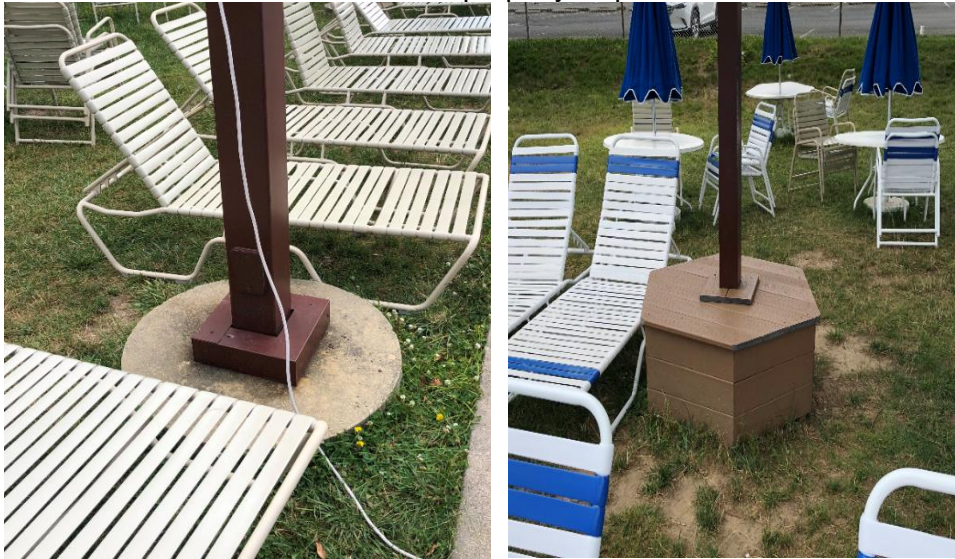
The square tube steel light posts are known to crack at their base welds. To reduce the risk of a premature failure, it is recommended that all bases be visually inspected at least annually by maintenance staff and any light posts showing significant corrosion removed from service. In some cases, the bases are hidden by collars and seating features. These visual obstructions will need to be removed in order to properly inspect the base welds.

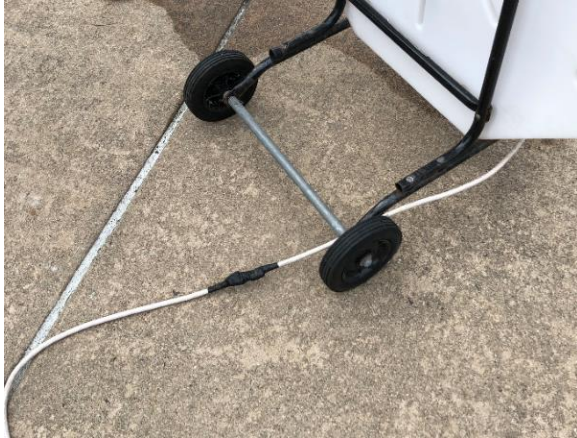
Rec. No.: 19-07-7	Priority: A	Pool – Competition Pool
<p>It is recommended that Lower Makefield:</p> <ul style="list-style-type: none"> <li>• Relocate the competition clock away from the pool edge.</li> <li>• Replace the electric cord on the clock (electrical tape repairs are not permitted in commercial applications).</li> <li>• Ensure all outdoor electrical equipment is plugged into outlets featuring ground fault circuit protection to reduce the risk of an electric shock incident.</li> </ul>		
<p>Status: New recommendation for 2019.</p>

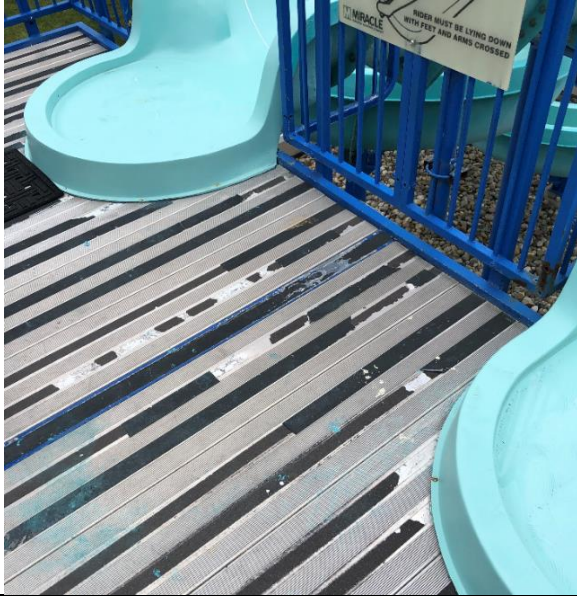
Rec. No.: 19-07-8	Priority: B	Pool – Water Slide
<p>It is recommended that Lower Makefield replace the damaged sections of anti-slip tape on the steps for the water slide.</p>		
<p>Status: New recommendation for 2019.</p>

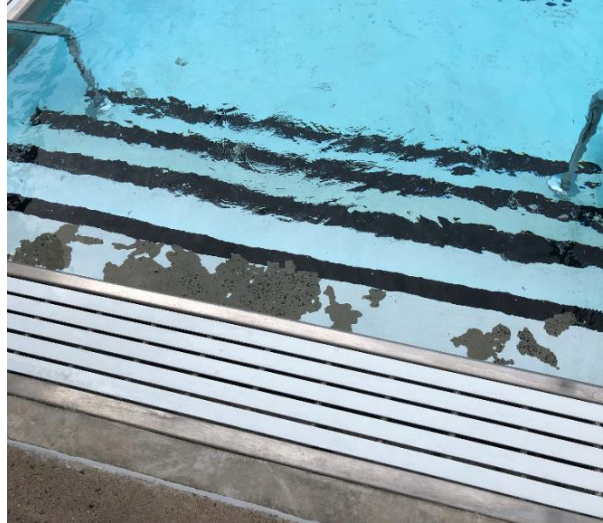
Rec. No.: 19-07-9	Priority: M	Pool – Water Slide
<p>The paint is coming up on the steps near the water slide. It is recommended that Lower Makefield recoat this area at the end of the season.</p>

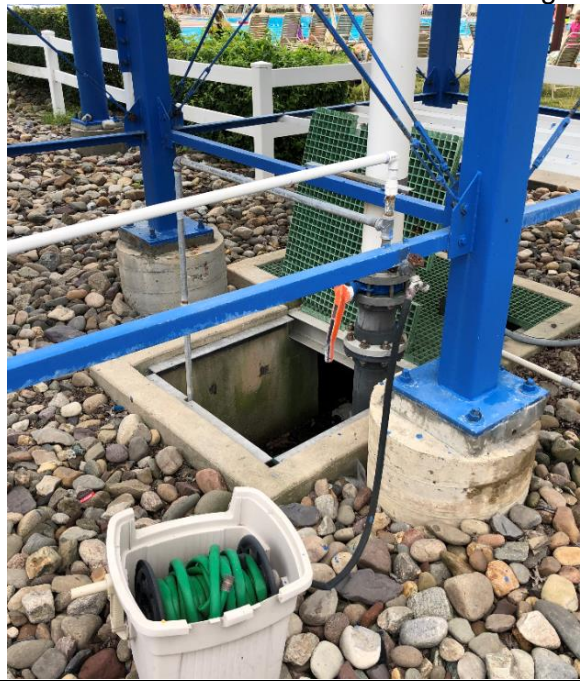
Rec. No.: 19-07-10	Priority: A	Pool – Water Slide
<p>A maintenance grate was propped open at the base of the water slide. It is recommended that Lower Makefield ensure all maintenance grates be replaced when work is completed.</p>

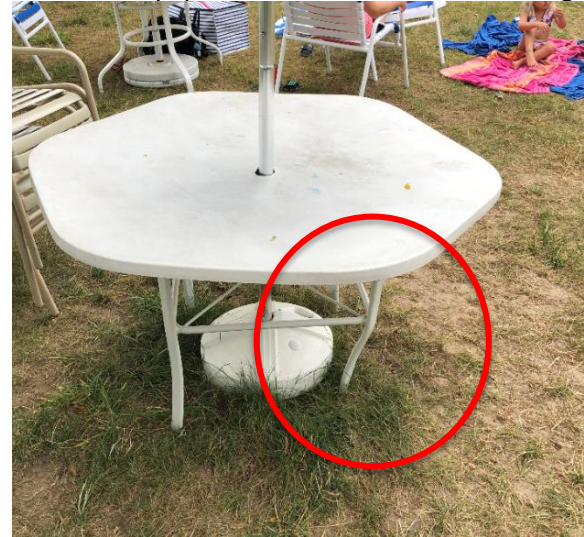
Rec. No.: 19-07-11	Priority: A	Pool – Furniture/Equipment
<p>It is recommended that Lower Makefield educate the pool staff to remove damaged furniture/equipment from service. A damaged table was observed to still be in service.</p>

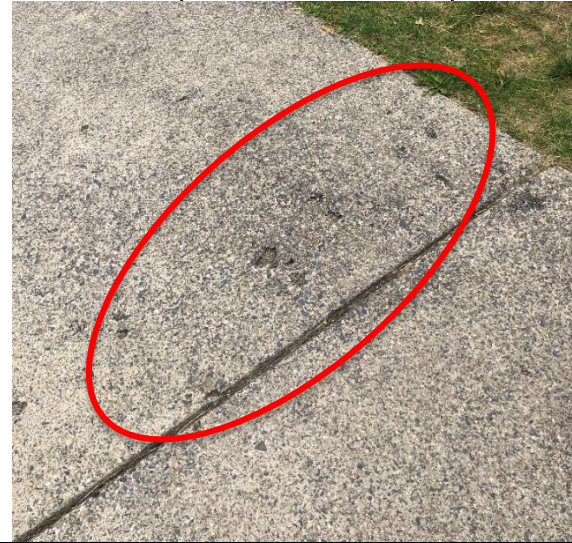
Rec. No.: 19-07-12	Priority: M	Pool – Sidewalk Adjacent to Kiddie Pool
<p>It is recommended that Lower Makefield repair the concrete sidewalk deterioration in the vicinity of the kiddie pool to eliminate the potential foot laceration hazard.</p>

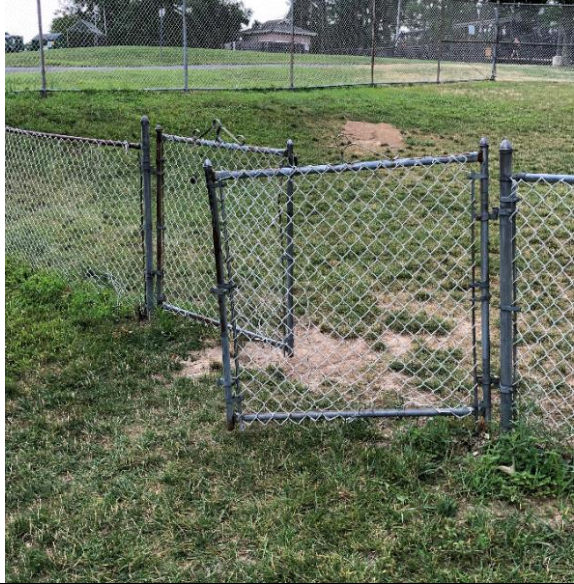
Rec. No.: 19-07-13	Priority: B	Pool – Kiddie Pool Perimeter Fence
It is recommended that Lower Makefield chain closed the unsecured gate leading from the kiddie pool area to the picnic pavilion area.

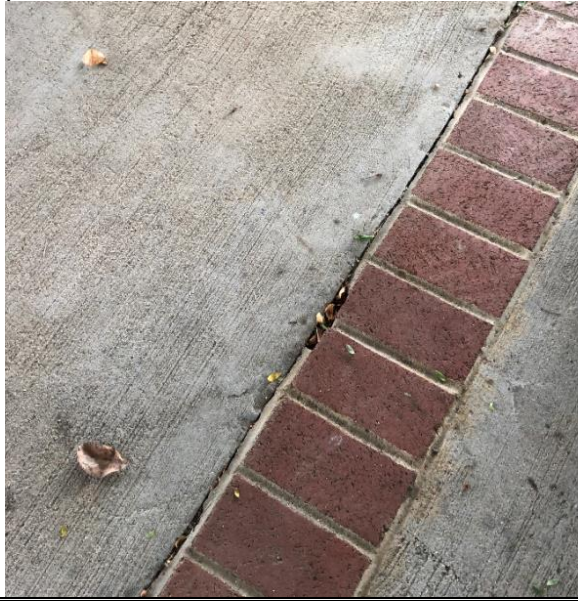
Rec. No.: 19-07-14	Priority: M	Pool – Picnic Pavilion
It is recommended that Lower Makefield repair the damaged brick mortar to eliminate the potential foot laceration hazard.

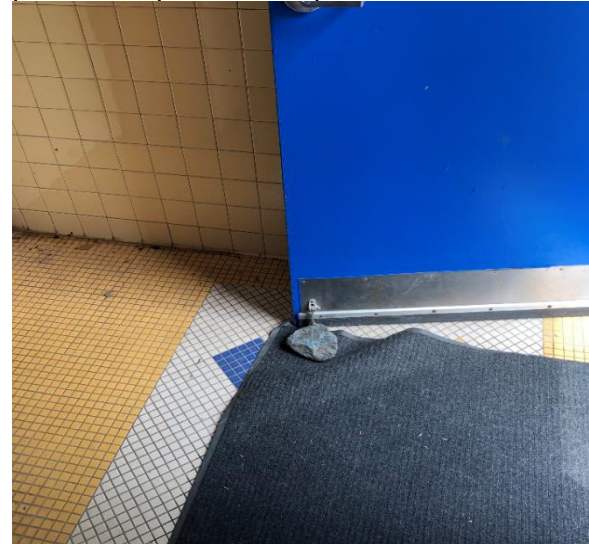
Rec. No.: 19-07-15	Priority: A	Pool – Men’s Restroom
<p>It is recommended that Lower Makefield not utilize improvised door stops. These create a potential trip and fall exposure. Rubber wedge door stops are recommended.</p>

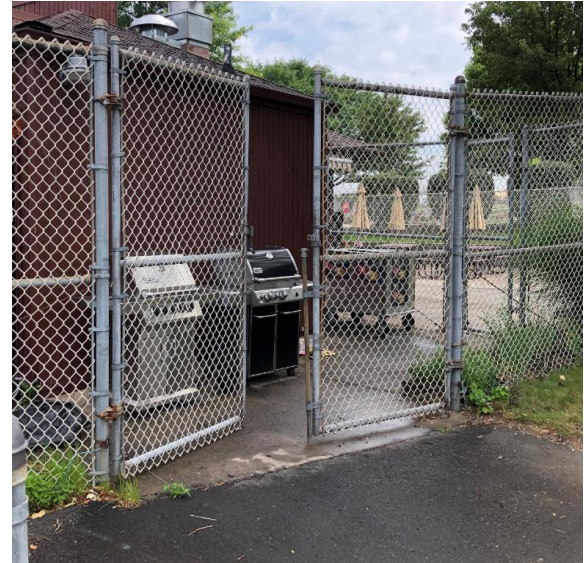
Rec. No.: 19-07-16	Priority: A	Pool – Perimeter Fencing
<p>The two perimeter fence gates adjacent to the snack shack were unsecured. It is recommended that Lower Makefield secure these gates to prevent unauthorized access into the pool facility.</p>
