STRUCTURAL EVALUATION REPORT

**INSPECTION & EVALUATION
OF THE
LOWER MAKEFIELD TOWNSHIP COMMUNITY POOL
LOCATED IN
LOWER MAKEFIELD, PENNSYLVANIA**

**THE TOWNSHIP OF LOWER MAKEFIELD
110 EDGEWOOD ROAD
YARDLEY, PA 19067**

NOVEMBER 2018

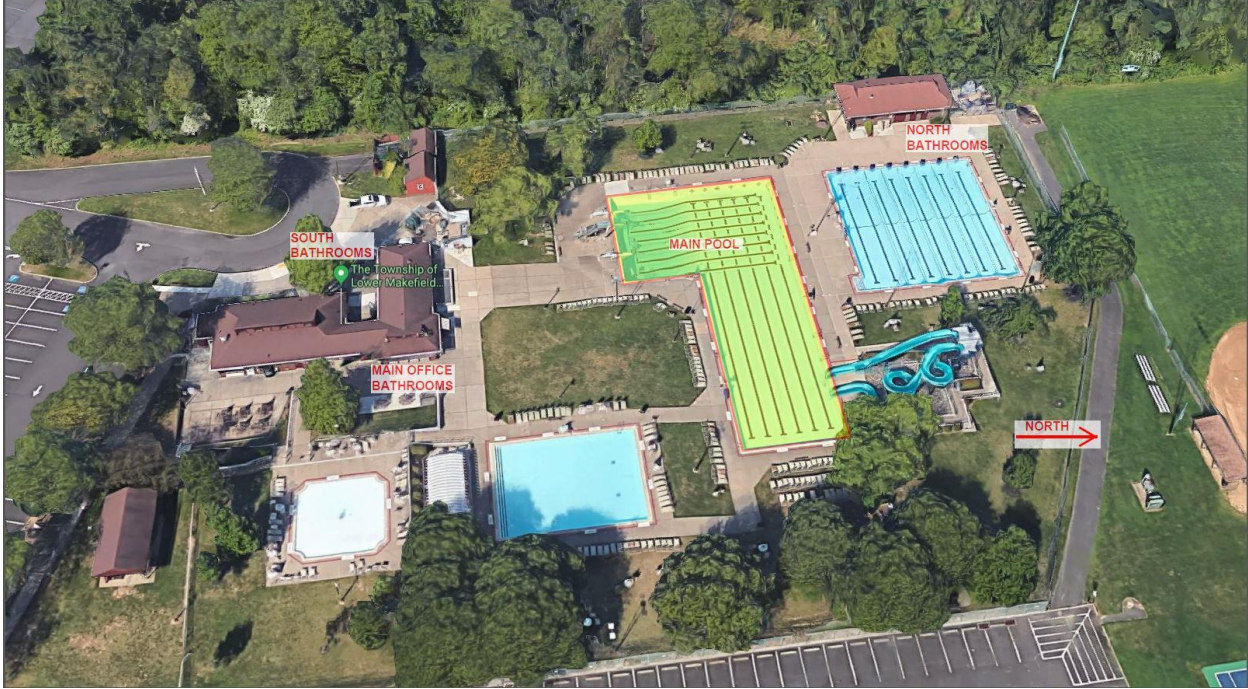
Figure 1 - Site Overview

The Lower Makefield Township Community Pool complex consists of several pools and buildings, identified in this report by their respective locations. The Main L-shaped pool and all bathroom facilities were inspected. A building location map is included in Appendix A of this report (*Figure 1*).
