The Pool at LMT Incident Report

RE: Safety Assessment of Municipal Pool

**RECOMMENDATIONS
POOL**

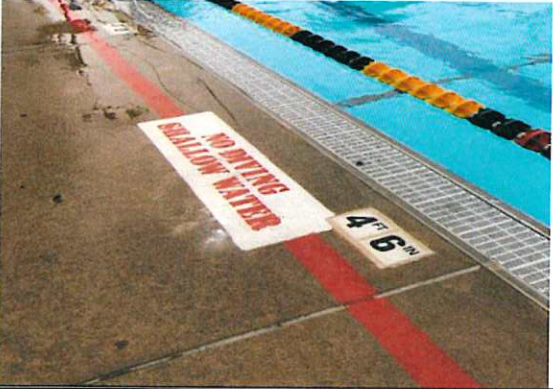
Rec. No.: 19-07-5	Priority: B	Pool – “No Diving” Pictograms
In conformance with the International Pool and Spa Code, it is recommended that Lower Makefield apply “No Diving” pictograms and depth markers as follows:		
<p><i>409.3 No diving symbol.</i> <i>Where the pool depth is 5 feet or less, the “No Diving” symbol shall be displayed. The symbol shall be placed on the deck at intervals of not greater than 25 feet and directly adjacent to a depth marker. Additional signage shall be in accordance with NEMA Z535.</i></p>		
<p>Source: https://codes.iccsafe.org/content/ISPSC2018/chapter-4-public-swimming-pools</p>

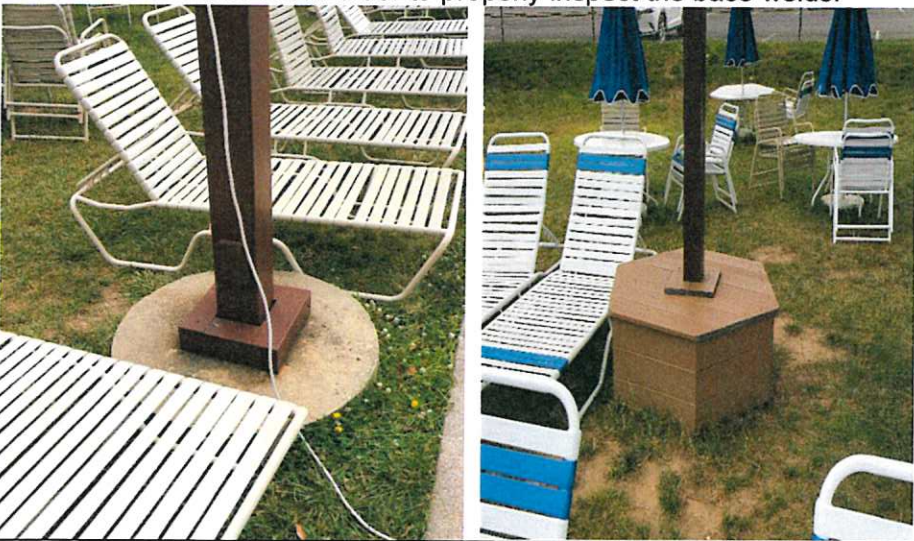
Rec. No.: 19-07-6	Priority: C	Pool - Light Posts
<p>The square tube steel light posts are known to crack at their base welds. To reduce the risk of a premature failure, it is recommended that all bases be visually inspected at least annually by maintenance staff and any light posts showing significant corrosion removed from service. In some cases, the bases are hidden by collars and seating features. These visual obstructions will need to be removed in order to properly inspect the base welds.</p>

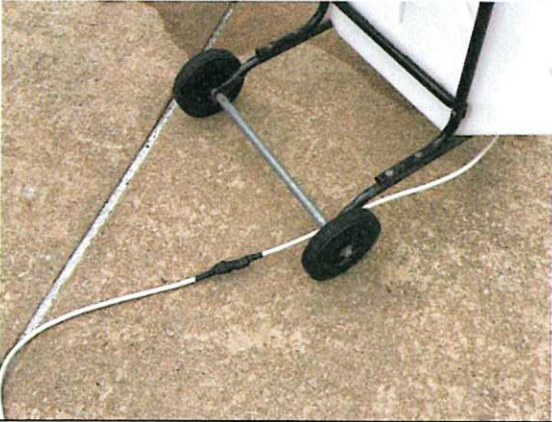
Rec. No.: 19-07-7	Priority: A	Pool – Competition Pool
<p>It is recommended that Lower Makefield:</p> <ul style="list-style-type: none"> • Relocate the competition clock away from the pool edge. • Replace the electric cord on the clock (electrical tape repairs are not permitted in commercial applications). • Ensure all outdoor electrical equipment is plugged into outlets featuring ground fault circuit protection to reduce the risk of an electric shock incident.

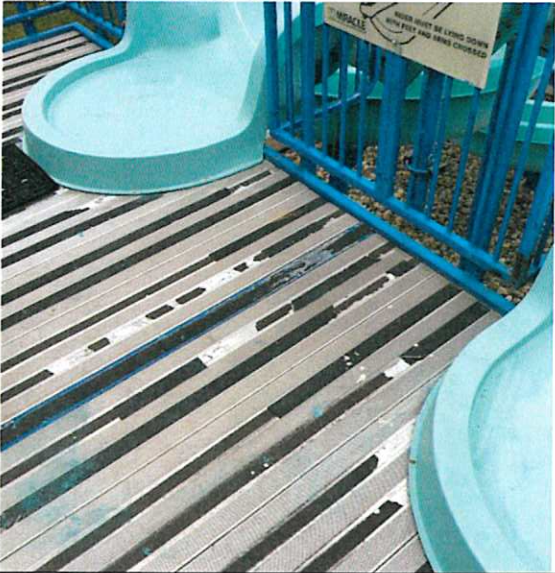
Rec. No.: 19-07-8	Priority: B	Pool – Water Slide
<p>It is recommended that Lower Makefield replace the damaged sections of anti-slip tape on the steps for the water slide.</p>

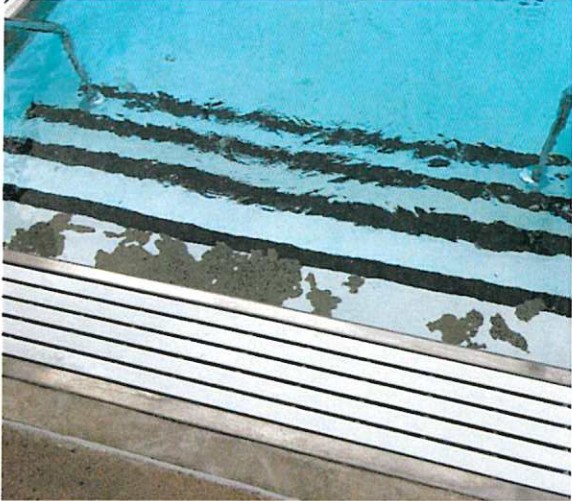
Rec. No.: 19-07-9	Priority: M	Pool – Water Slide
<p>The paint is coming up on the steps near the water slide. It is recommended that Lower Makefield recoat this area at the end of the season.</p>

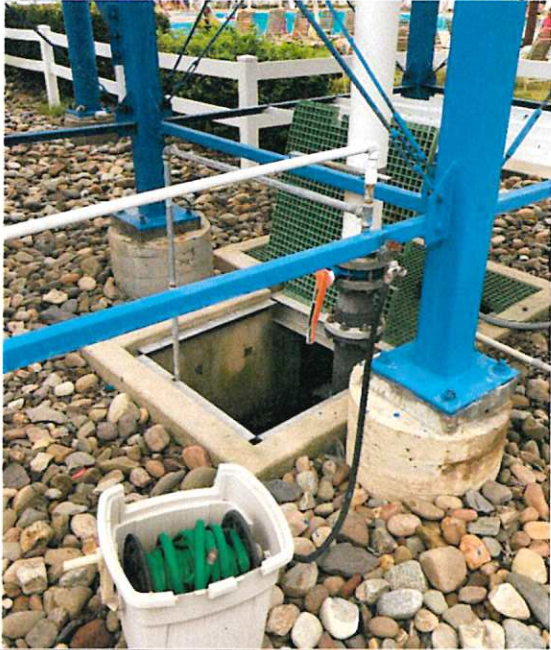
Rec. No.: 19-07-10	Priority: A	Pool – Water Slide
<p>A maintenance grate was propped open at the base of the water slide. It is recommended that Lower Makefield ensure all maintenance grates be replaced when work is completed.</p>

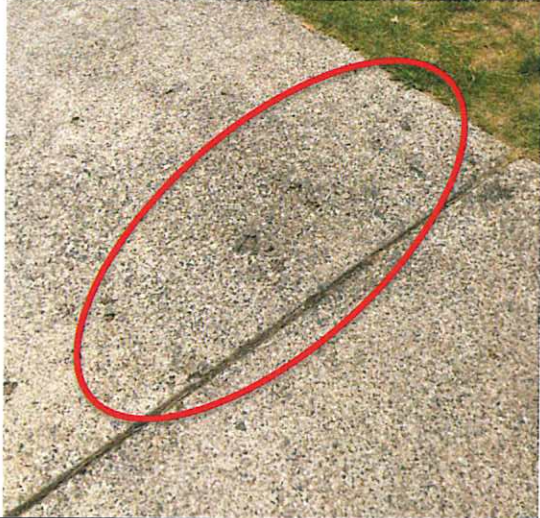
Rec. No.: 19-07-12	Priority: M	Pool – Sidewalk Adjacent to Kiddie Pool
<p>It is recommended that Lower Makefield repair the concrete sidewalk deterioration in the vicinity of the kiddie pool to eliminate the potential foot laceration hazard.</p>

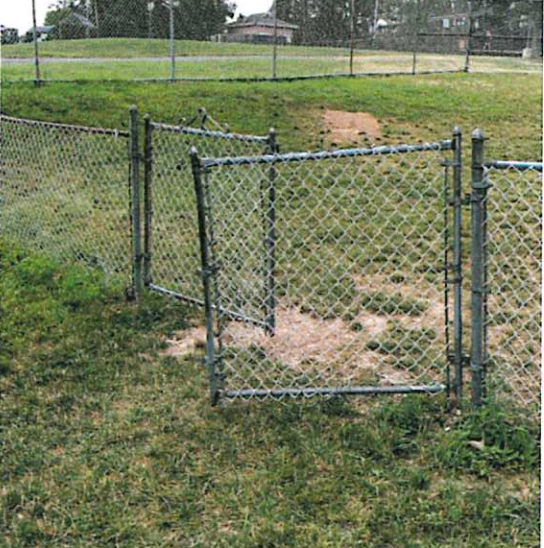
Rec. No.: 19-07-13	Priority: B	Pool – Kiddie Pool Perimeter Fence
It is recommended that Lower Makefield chain closed the unsecured gate leading from the kiddie pool area to the picnic pavilion area.

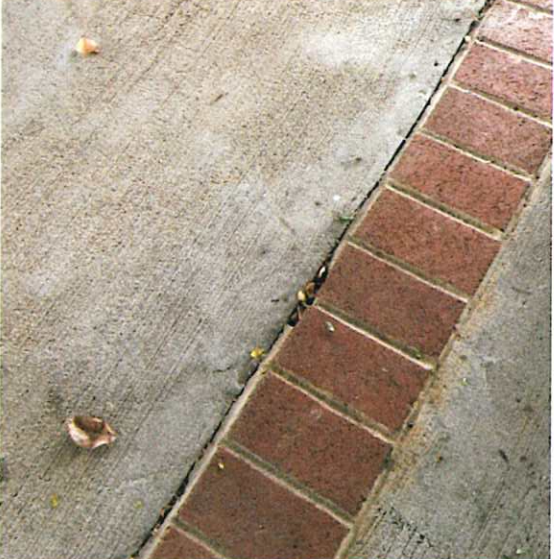
Rec. No.: 19-07-14	Priority: M	Pool – Picnic Pavilion
It is recommended that Lower Makefield repair the damaged brick mortar to eliminate the potential foot laceration hazard.

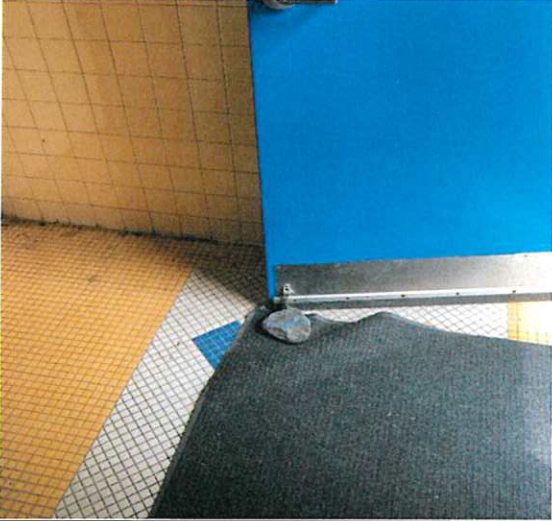
Rec. No.: 19-07-15	Priority: A	Pool – Men’s Restroom
<p>It is recommended that Lower Makefield not utilize improvised door stops. These create a potential trip and fall exposure. Rubber wedge door stops are recommended.</p>

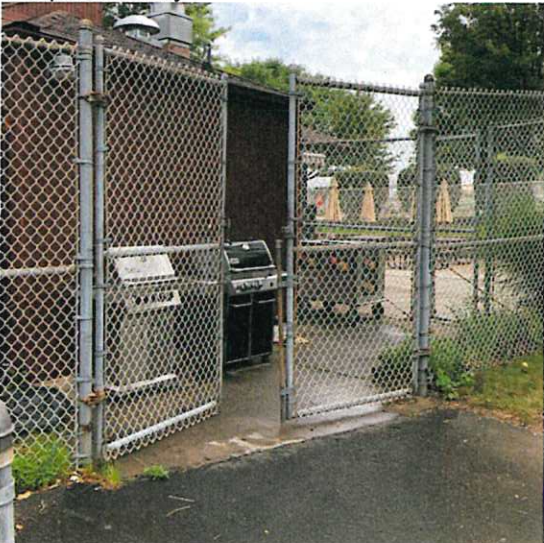
Rec. No.: 19-07-16	Priority: A	Pool – Perimeter Fencing
<p>The two perimeter fence gates adjacent to the snack shack were unsecured. It is recommended that Lower Makefield secure these gates to prevent unauthorized access into the pool facility.</p>
